YAMAHA

PARTS FAILURES IDENTIFICATION GUIDE

LIT-11661-00-PF

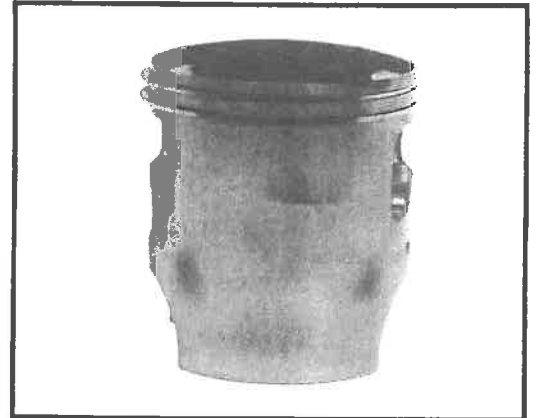
Broken Piston

This shows breakage of the piston intake skirt.

These failures can be caused by excessive clearance between the piston and the cylinder allowing the piston to rock back and forth in the cylinder. Possible causes are:

- Ingestion of foreign objects or material, (dirt, sand, or water)
- Improperly bored cylinder
- Piston worn too much and should have been replaced earlier

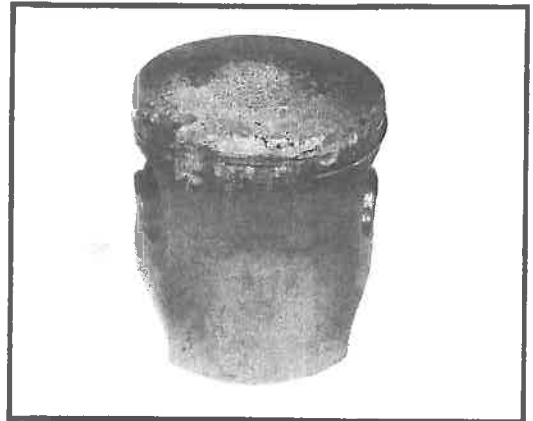
Seized Piston (seize marks on exhaust side and ring land eroded away)

This shows heavy seize marks on the exhaust side and badly eroded ring lands. This is usually caused by:

- Lean carburetion
- Engine sucking air (air leak)
- Timing too far advanced

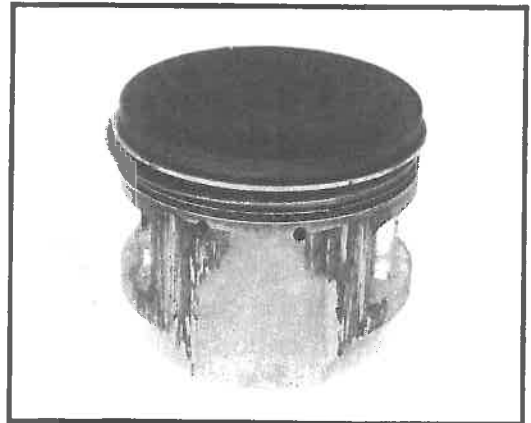
4-stroke Piston Seizure

This shows piston seizure on a 4-stroke engine. This failure is usually caused by the piston overheating because of:

- Blocked cooling fins or cooling system failure
- Carburetor jetting too lean
- Ignition timing too far advanced
- Lubrication system failure

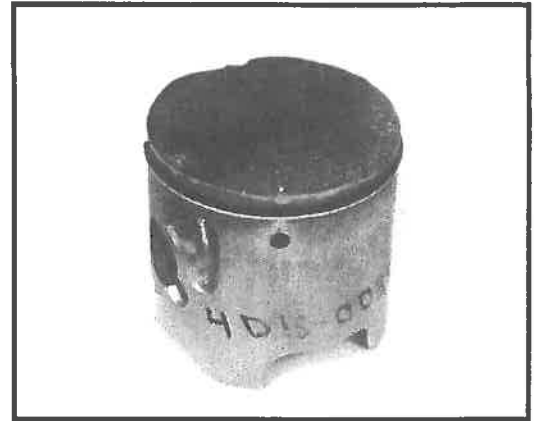
This type of failure is usually caused by the piston ring locating pin dislodging and allowing the ring to rotate. The dislodging of the locating pin can be caused by sustained high RPM operation.

Ring(s) can also rotate because of excessive wear or detonation causing the ring groove to get wider.

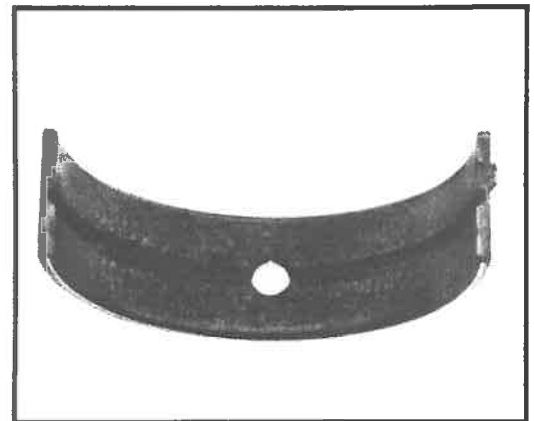
Large dirt particles can embed in the soft bearing material. This causes wear and decreases the life of both the bearing and its journal. **Dirt is the most frequent cause of bearing failure.** Prevent this by cleaning the area surrounding the bearing thoroughly during installation and by proper maintenance of any air and oil filters.

These show when a particle of dirt was left during bearing installation; it caused damage by pushing the bearing inward increasing localized pressure and heat.

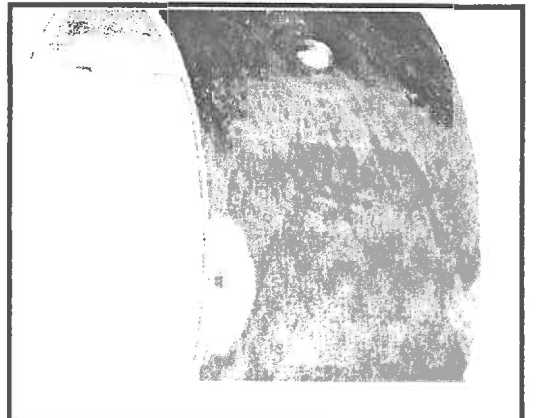
Excessive crush frequently results when someone files parting edges of bearing caps. Excessive crush brings about inward collapse of the bearing insert resulting in premature bearing failure and crankshaft damage.

The opposite of excessive crush is insufficient bearing crush which can result in destructive action to both bearing and crankshaft. Any polished area on bearing insert back, or at parting edges, is a true indicator of insufficient crush. Polishing action is caused by bearing movement in bearing bore. Insufficient crush causes loss of heat transfer and bearing lining failure. A few causes of insufficient crush are:

- Insufficient torque because of damaged mating surfaces at parting edges of caps and bores.
- Capscrews bottoming in blind threads, resulting in false torque reading
- Bearing bore wear or cap stretch.

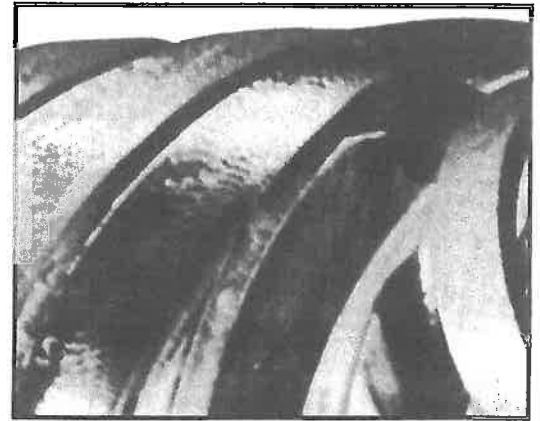
The surface of this gear shows waviness; a typical case of rippling on a hardened hypoid pinion. Rippling generally occurs on highly loaded gears.

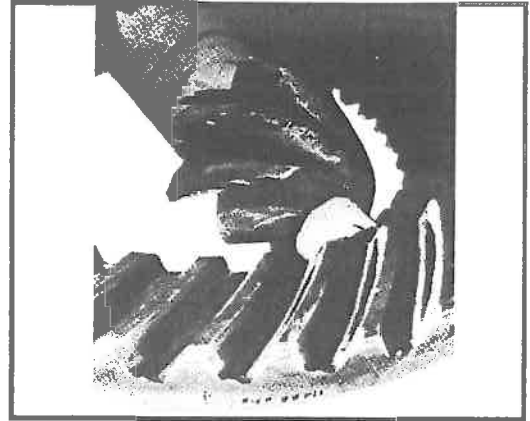
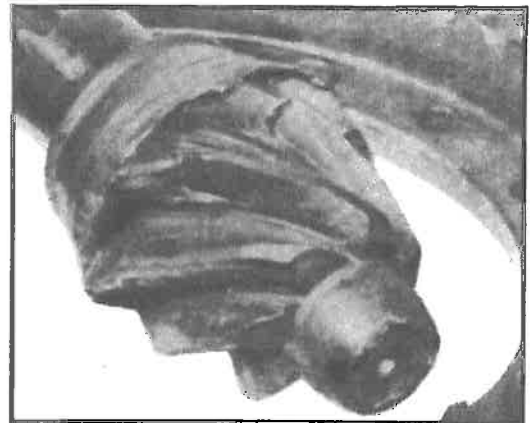
The ring gear teeth show discoloration and distortion. This type of failure is caused by heat generated from improper lubricant, low lubricant level, or infrequent lubricant change. In the presence of any of these conditions the surface overheats because of excessive friction.

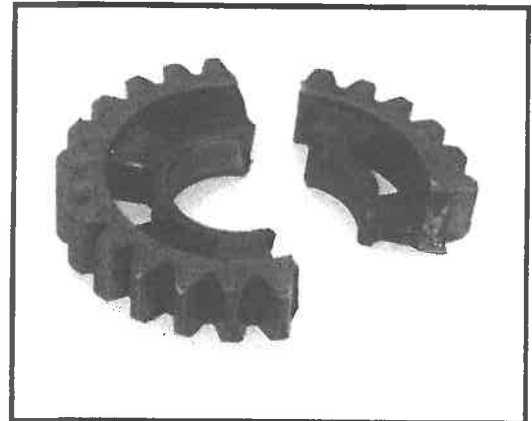
This shows gear breakage due to excessive impact caused by:

- Clutch not completely disengaged during transmission shifting.
- Abrupt binding of the drive line - such as a broken drive chain binding the counter sprocket or landing a dirt bike off a jump in the wrong gear.

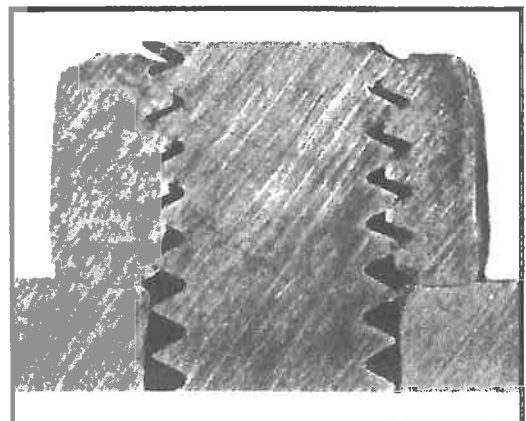
Nut Dilation

When a low grade nut is used in assembly, the washer face of the nut expands in diameter. Replace with higher strength nut, add a hard washer in joint or use a flanged nut.
